Manhole Inspection Summary

Manhole # S08AA2007MH

Insp Date: **10/10/06 10:03 AM**

Location Address: **7000 REISTERSTOWN RD**

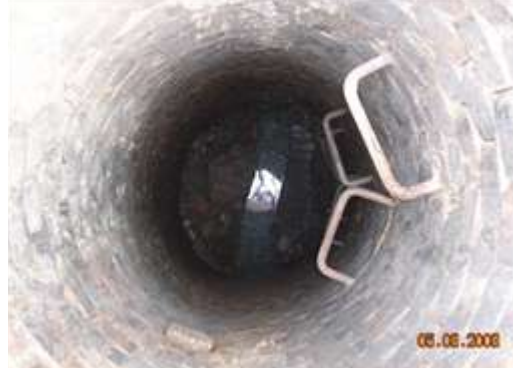
Top View

Adjustment and Corbel deterioration and infiltration. Evidence of surcharge - Bench debris. Channel debris.

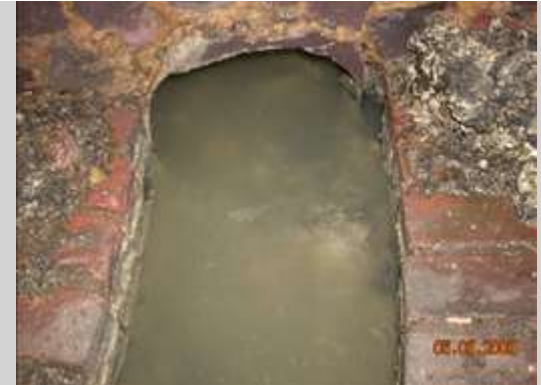
10 in. Circular Gravity Sewer Pipe Out @ 12 O'Clock

Deposits: ☐ None ☒ **Mud** ☐ Sludge ☒ **Debris** ☒ **Grease**

Silt Depth: **3** (in.) Deposits Extent: **Medium**

Infiltration: **None** Pipe Seal Cond: **Cracked**

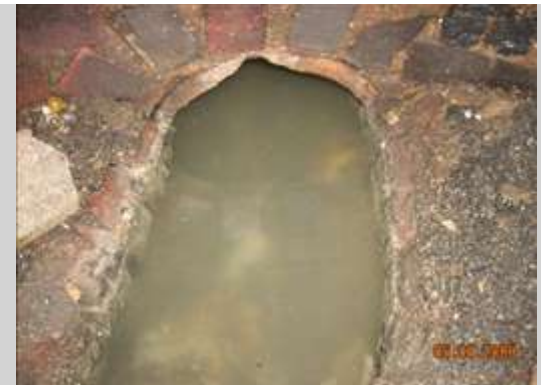
10 in. Circular Gravity Sewer Pipe In @ 6 O'Clock

Deposits: ☐ None ☒ **Mud** ☐ Sludge ☒ **Debris** ☐ Grease

Silt Depth: **2** (in.) Deposits Extent: **Light**

Infiltration: **Evidence** Pipe Seal Cond: **Cracked**
